SAND98-1016

Damage Tolerance Assessment of Bonded Composite Doubler Repairs for Commercial Aircraft Applications

Dennis Roach

Sandia National Laboratories

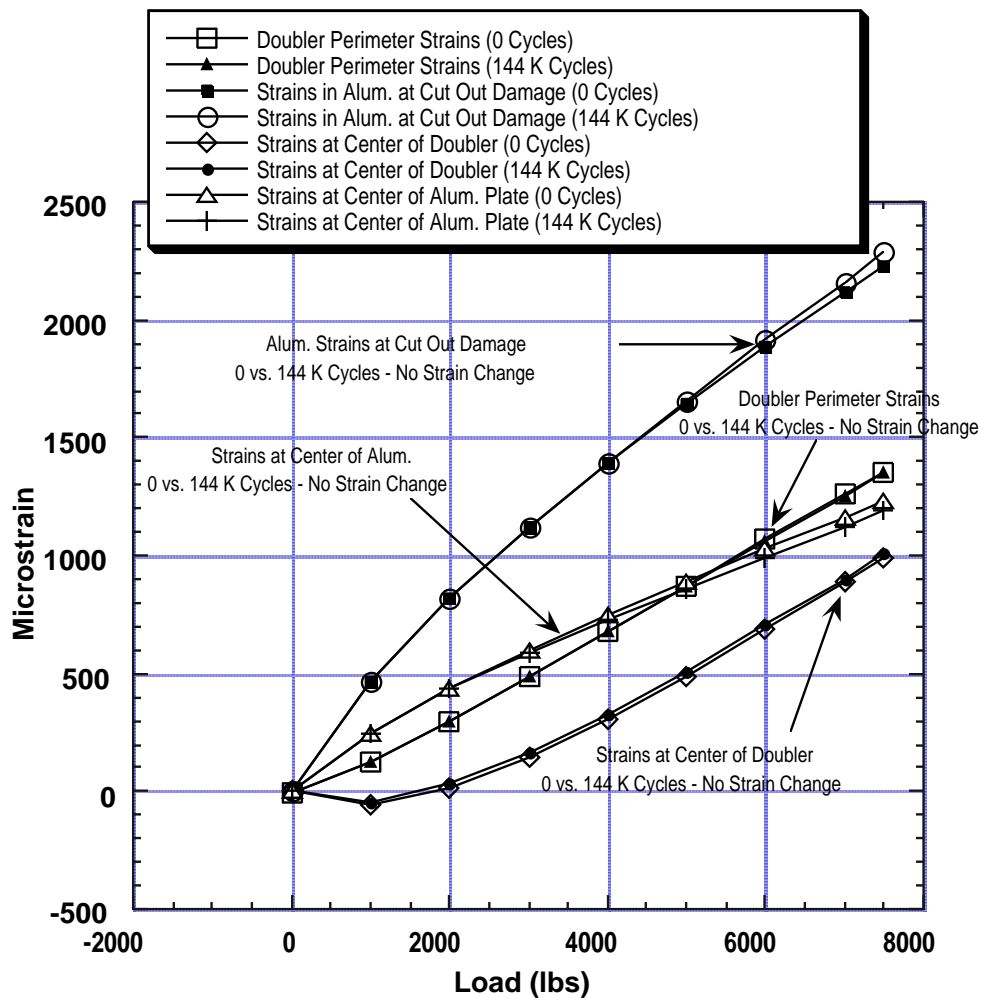
- a. No Change in Strain Field - Configurations BE-5 (aluminum cut-out damage), BE-7 (unflawed specimen), BE-8 (impact and disbond over fatigue crack), and BE-9 (multiple impacts and disbond over fatigue crack) exhibited little or no change in strain field during the course of their fatigue tests. The NDI before-and-after results in Figures 32-38 show that the initial “programmed” flaws did not change shape nor did any new flaws develop as a result of the fatigue loads. Quantitatively, the strain gage values acquired before and after fatigue testing substantiate the NDI results. Figure 63 plots the strain field for configuration BE-5 (specimen Lock5) before and after 144,000 fatigue cycles. The before-and-after plots lie on top of each other

Figure 63: Strain Field in Configuration BE-5 (Lock5) Remains Unchanged Over 144,000 Fatigue Cycles - No Flaw Growth in Doubler Installation

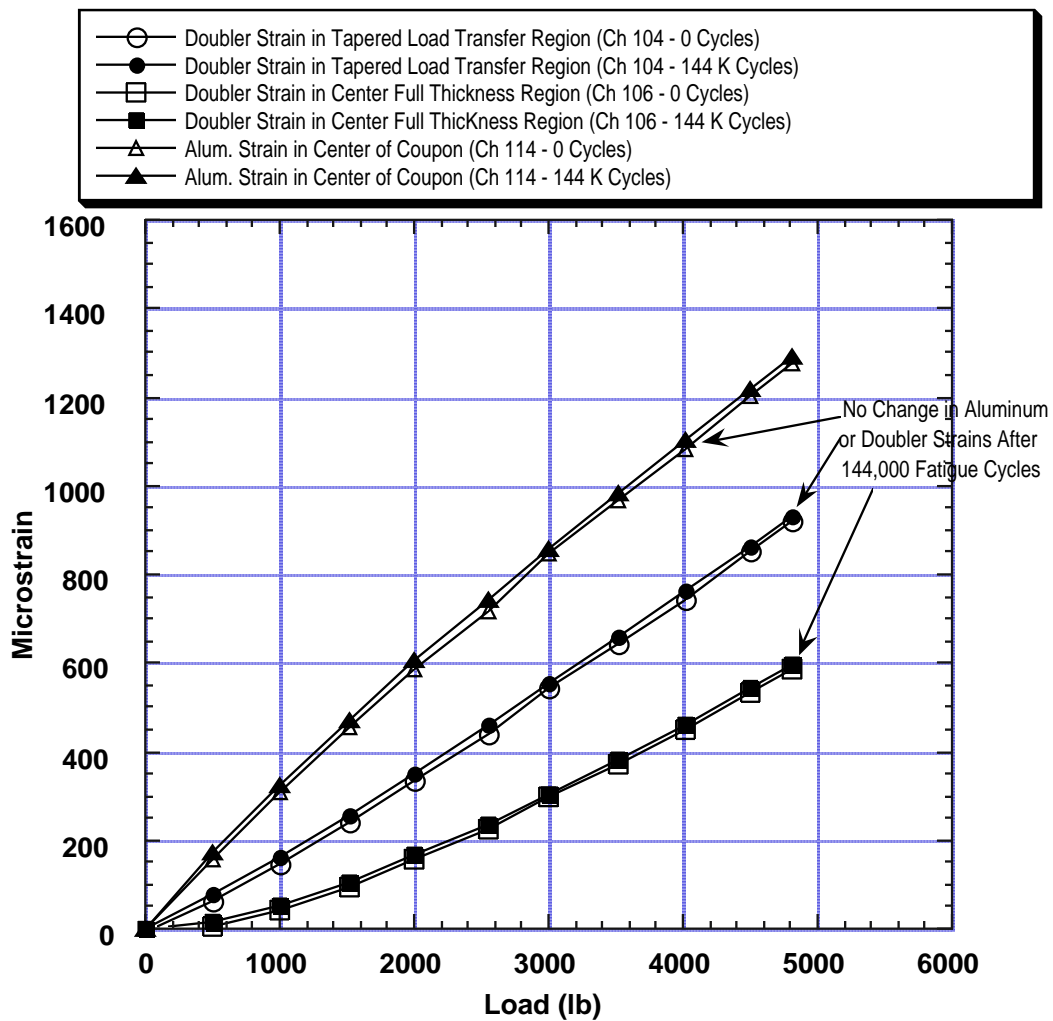
demonstrating an unchanged strain field. Similarly, Figure 64 shows that the strains in the BE-7 configuration (specimen Lock9) were undisturbed by 144,000 fatigue cycles. Figures 65 and 66 show that, for the most part, configurations BE-8 (Lock14) and BE-9 (Lock20) were unaffected by the fatigue cycles. However, both configurations showed slight changes around the center crack growth area. In configuration BE-8, the strains increased in doubler channel 124 and aluminum channel 132 (ref. Fig. 65). Both of these channels are adjacent to the implanted fatigue crack which grew 0.56" in 180,000 cycles. Configuration BE-9 displayed the same phenomena where doubler channel 144 and aluminum channel 148 increased slightly as the fatigue crack grew 0.77" in 99,000 cycles (ref. Fig. 66).

Figure 64: Strain Field in Configuration BE-7 (Lock9) Remains Unchanged Over 144,000 Fatigue Cycles - No Flaw Growth in Doubler Installation

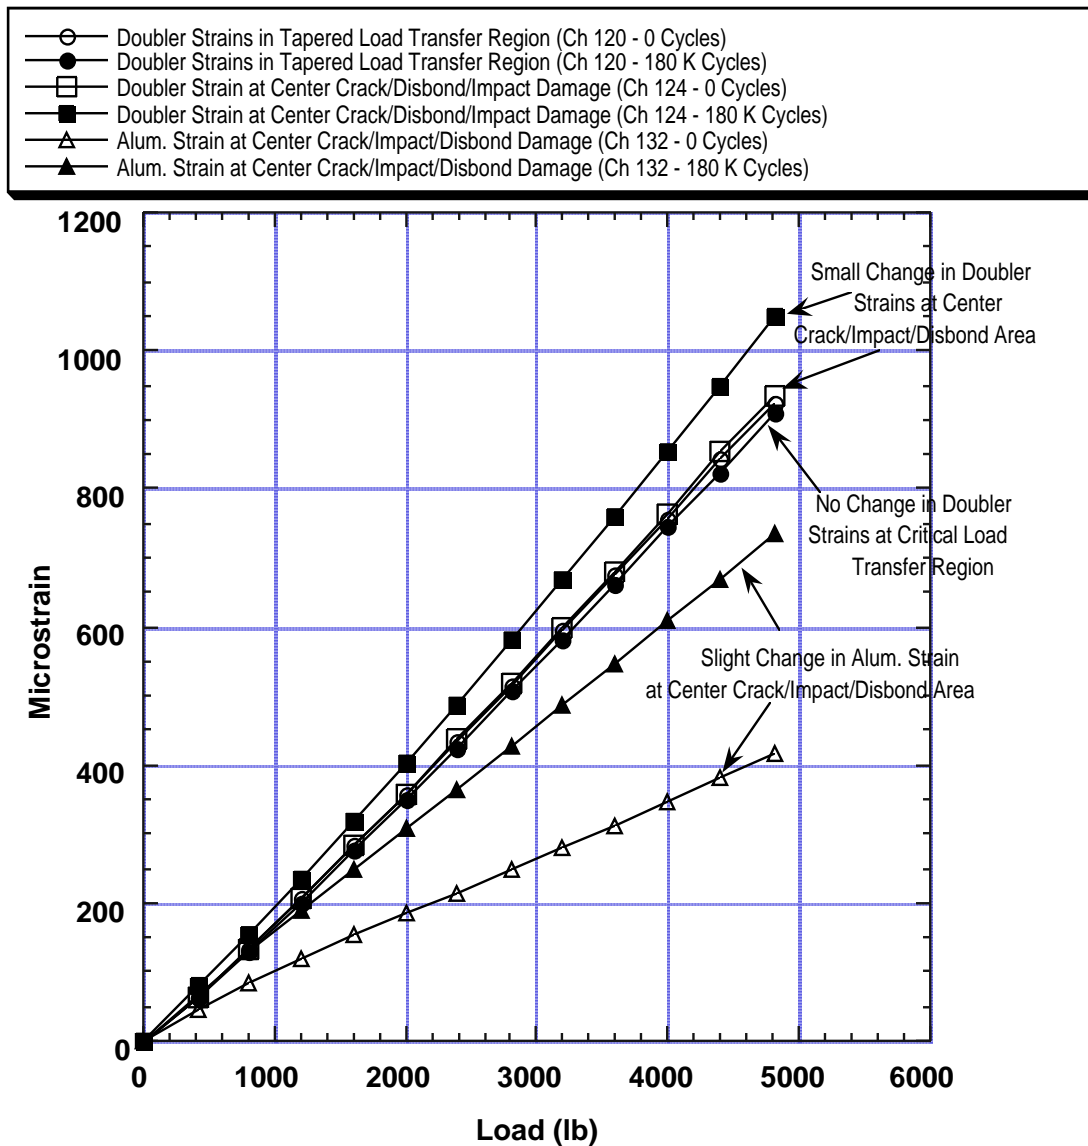
Figure 65: Strain Field in Configuration BE-8 (Lock14) Undergoes Slight Changes Due to Aluminum Crack Growth - No Flaw Growth in Doubler Installation

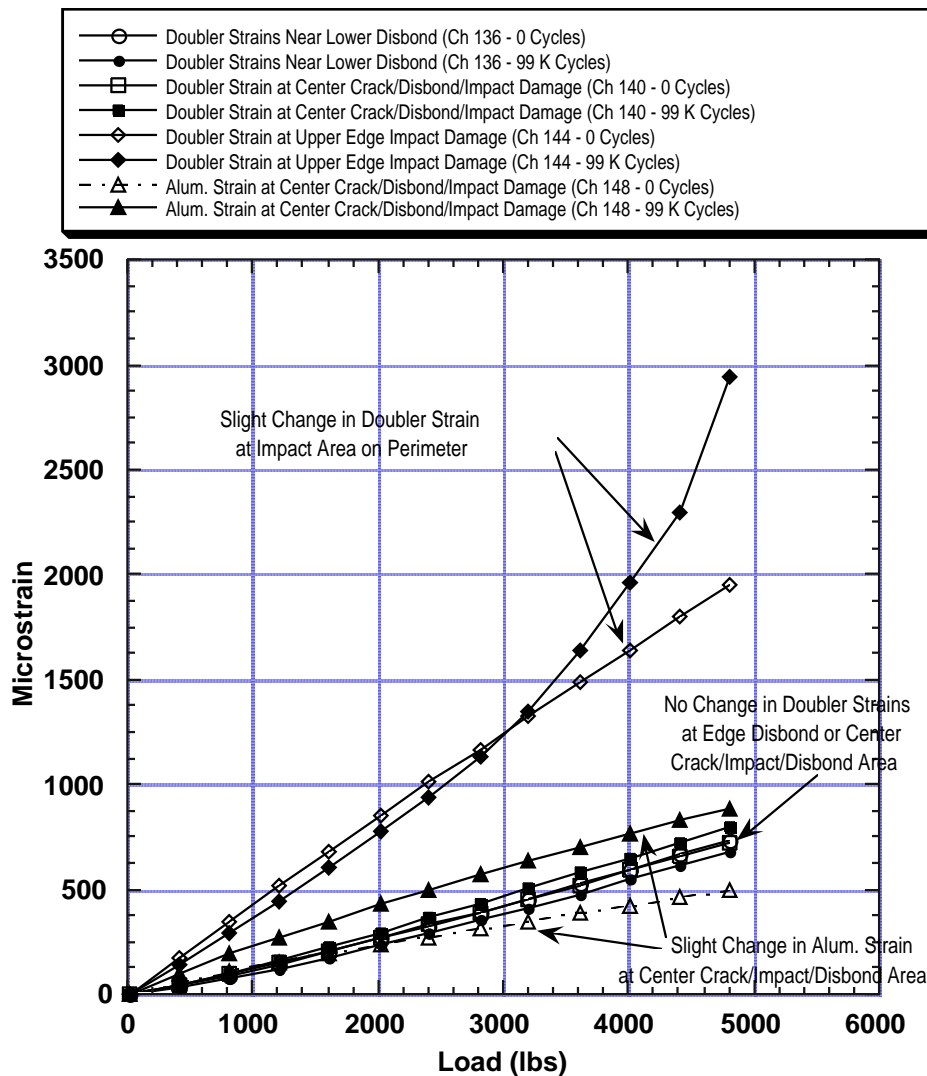
Figure 66: Strain Field in Configuration BE-9 (Lock20) Undergoes Slight Changes Due to Aluminum Crack Growth - No Flaw Growth in Doubler Installation

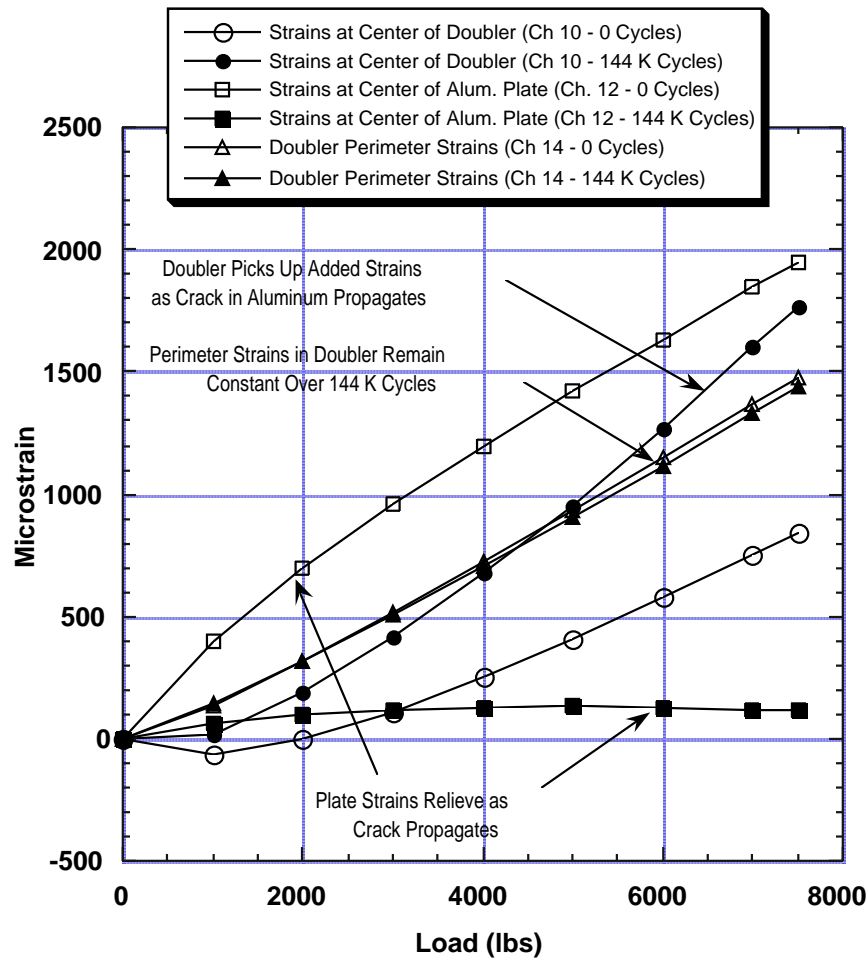
Figure 67 points out the increasing load picked up by the composite doubler as the aluminum crack propagates in the BE-1 configuration. At N= 0 cycles, the strains at the center of the doublers amounted to 30% of the total strain in the aluminum plates. At N = 144,000 cycles, however, the same strain gages registered 60% to 70% of the total strain in the plate. The N = 0 and N = 144,000 cycles curves in Figure 67 show how the doubler picks up more load as the crack propagates and the plate relieves its load (ref. channel 10). The related reduction in plate strains can be seen by looking at the channel 12 strains before and after the fatigue tests (drop from 67% of total strain to less than 3% of total strain in plate). Figure 68 shows the similar results obtained in configuration BE-4.

Figure 67: Performance of Composite Doubler Over Crack - Crack Propagation Causes Aluminum to Off Load Strain to Doubler; Configuration BE-1 (Lock1)

It is important to note three items regarding this change in strain field: 1) the composite doubler was able to meet its design objectives and absorb additional load as required, 2) the effects were localized about the crack (i.e. the strains around the perimeter - especially in the critical load transfer region - remained unchanged), and 3) the change in flaw shape (ref. Fig. 30) was caused by a cohesive failure of the adhesive, not a growth in the implanted disbond. This latter point is key because the cohesive failure indicates that the installation was good and that the full strength of the adhesive was achieved. Disbonds, indicated by a lack of adhesive on either the laminate or aluminum mating surface, are undesirable since they can occur at lower loads.

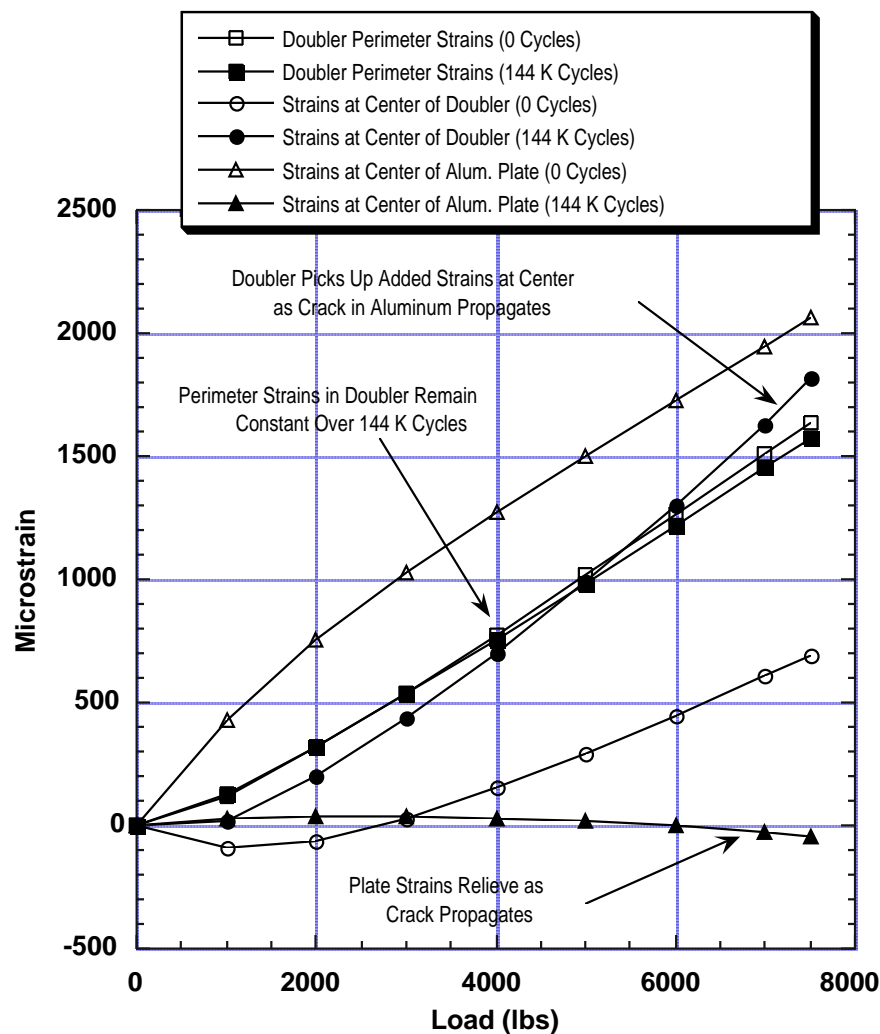
Figure 68: Performance of Composite Doubler Over Crack - Crack Propagation Causes Aluminum to Off Load Strain to Doubler; Configuration BE-4 (Lock4)

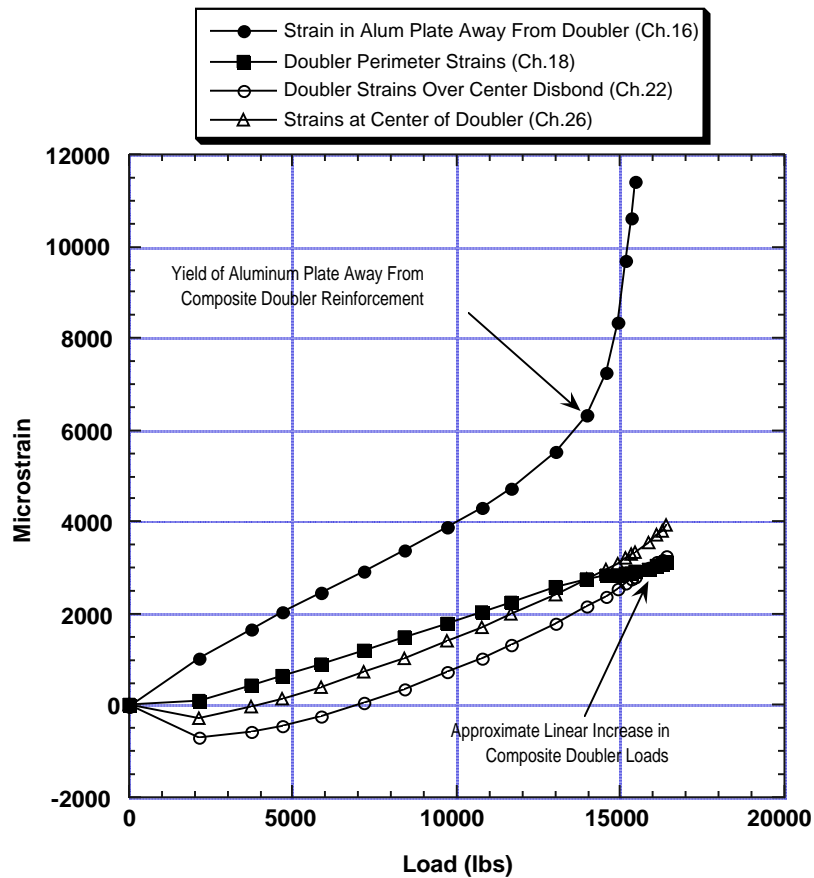
Figure 69 shows the strain field in specimen BE-2 up through failure. The aluminum plate away from the doubler (channel 16) began to yield at approximately 12,000 lbs. while the doubler continued to increase its load in a linear fashion. This load/response process continued until failure occurred at 103 ksi and the specimen could no longer sustain an increasing load. *Figure 69 illustrates that the composite doubler was able to transmit stresses in the plastic regime and that extensive yielding/loading beyond the initial yield level was required to fail the installation.*

1. Specimen BE-1: fatigue testing propagated the unabated crack to 2.25” in length; measured static ultimate tensile strength was 103 ksi.
2. Specimen BE-2: fatigue testing propagated the stop-drilled crack (crack reinitiation at 126,000 cycles) to 1.625” in length; measured static ultimate tensile strength was 88 ksi.

Figure 69: Strain Fields in Composite Doubler and Aluminum Plate During Ultimate Failure Test (Configuration BE-2)
